**Flood Control Project Maintenance  
Levee Inspections**

## Maintenance Issue Types Only, Levee Inspection Report By Mile - Spring 2018

### Reclamation District No. 2031 Elliot

Waterway	Bank	Unit Miles	Inspection Start/End	Inspector
Unit No. 01 Stanislaus River	Left	7.07	05/16/2018 05/16/2018	Sterling York

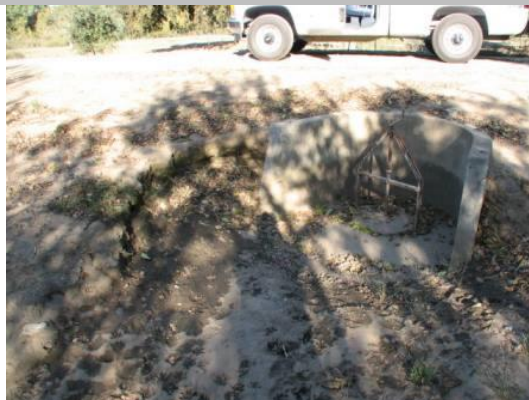
Photo 1 of 1 : SP\_2018\_RD2031\_307\_8\_20180515\_00007.jpg

LM Start	1.58	Rating **	U	Issue No.	8
LM End	1.58	Issue Type +	Ma	Location *	WS
Category	Earthen Levee			GPS Latitude/Longitude	
				Start	End
Item	Erosion / Bank Caving			37.698610 °	37.698610 °
				-121.174598 °	-121.174598 °
DWR ID	DWR_RD2031_01_s_2012_8				
Comment Code					
E1 : Note and monitor erosion site.					
Inspector Comment					
Active erosion is occurring around irrigation inlet.

10/26/2011 Active erosion shown around irrigation inlet.

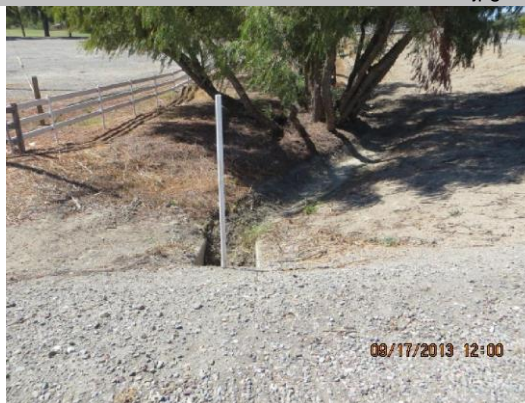
Photo 2 of 3 : UCIP\_SP\_2018\_51374\_34885.jpg

Concrete headwall on WS toe.

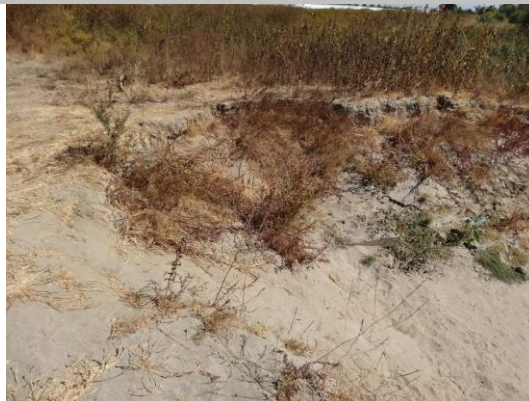
Photo 3 of 4 : SP\_2018\_RD2031\_308\_1\_20180515\_00003.jpg

LM Start	<b>4.29</b>	Rating **	A/W	Issue No.	<b>1 (cont)</b>
LM End	<b>5.97</b>	Issue Type +	Ma	Location *	WS

Close view of the pocket erosion.
